Memorandum

Date: *August 15, 2014*

Subject: *Oversight Summary Report
CPG Oversight of RM 10.9 Removal Action
Lower Passaic River Restoration Project*

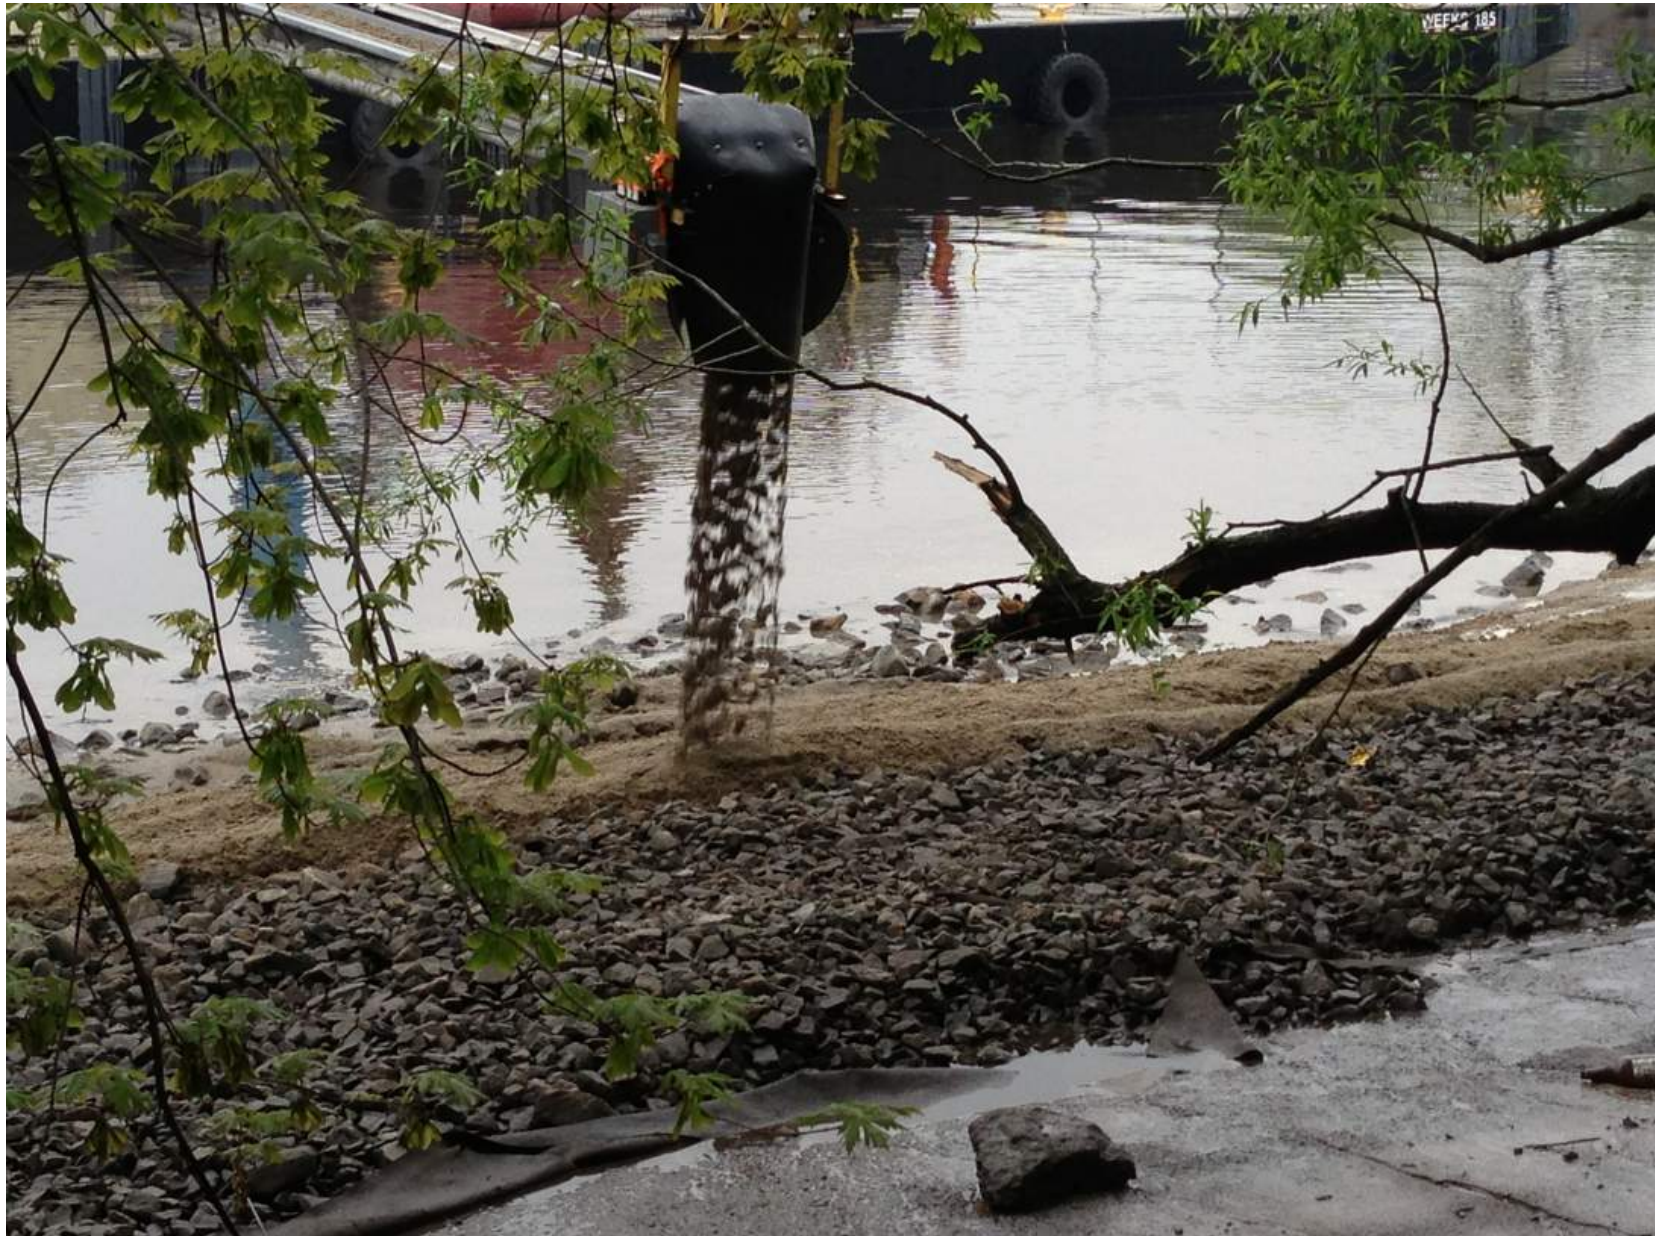
Habitat Layer Application

Sand was applied in radial passes using the telebelt.

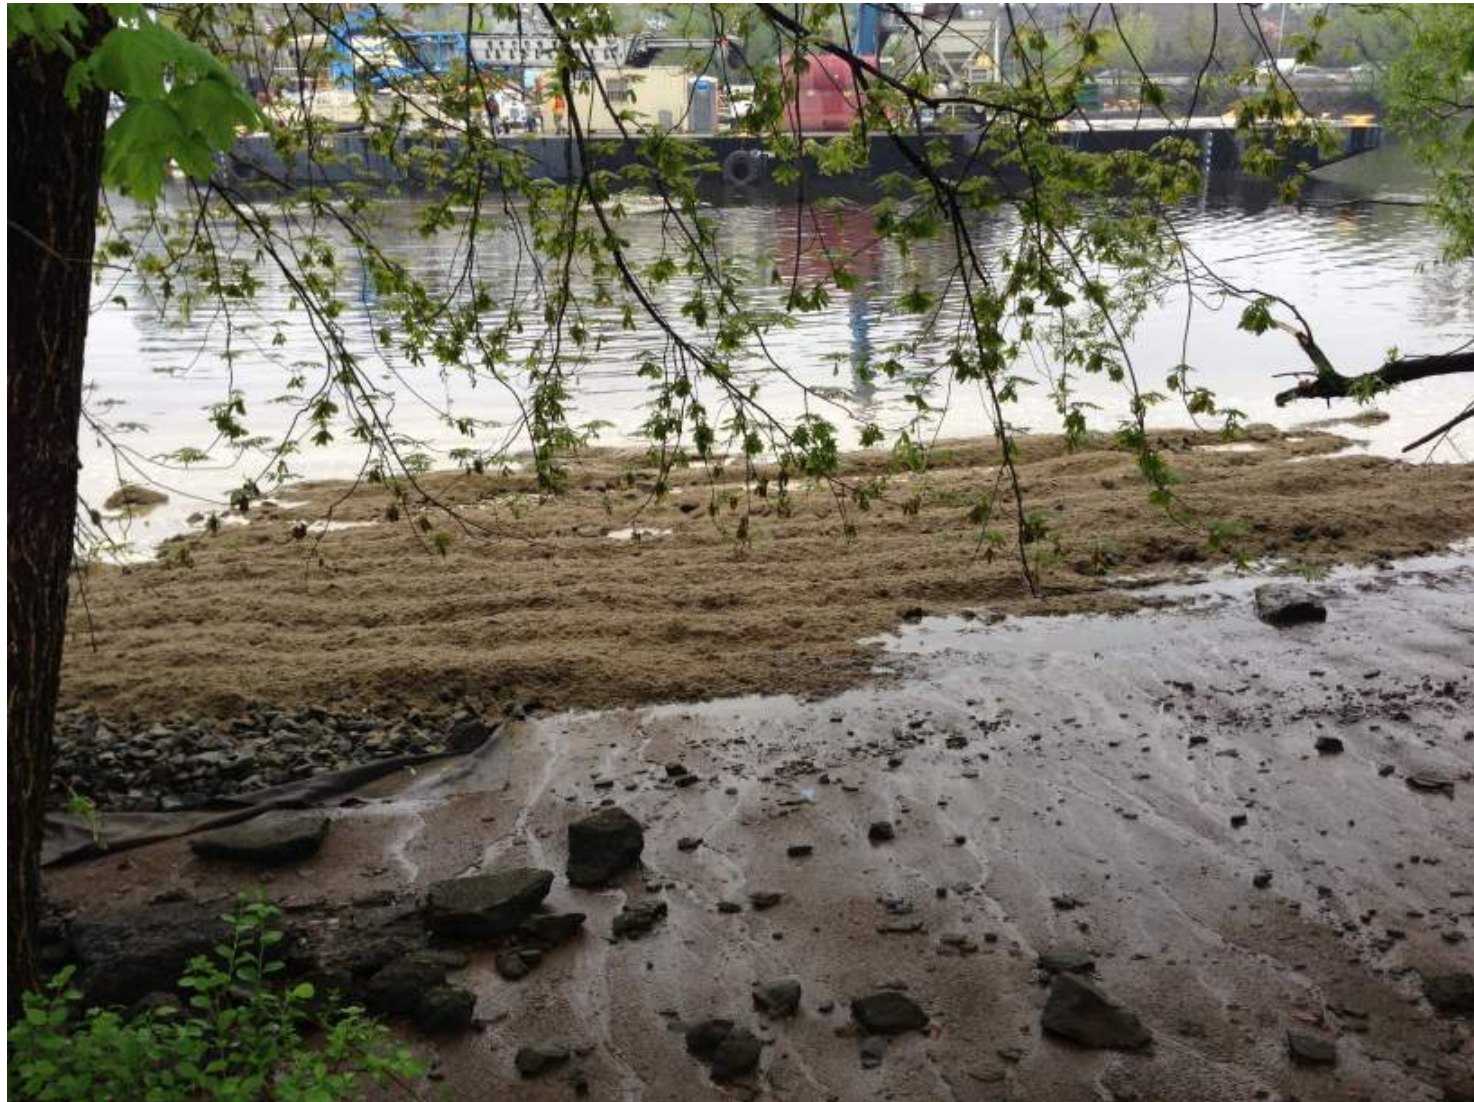
Habitat Layer after One Lift

The above photograph shows the southeast corner of the capping area after one pass of the telebelt. All visible areas will be examined tomorrow at low tide to assess whether one lift or two lifts of sand are required to sufficiently cover the armor stone.

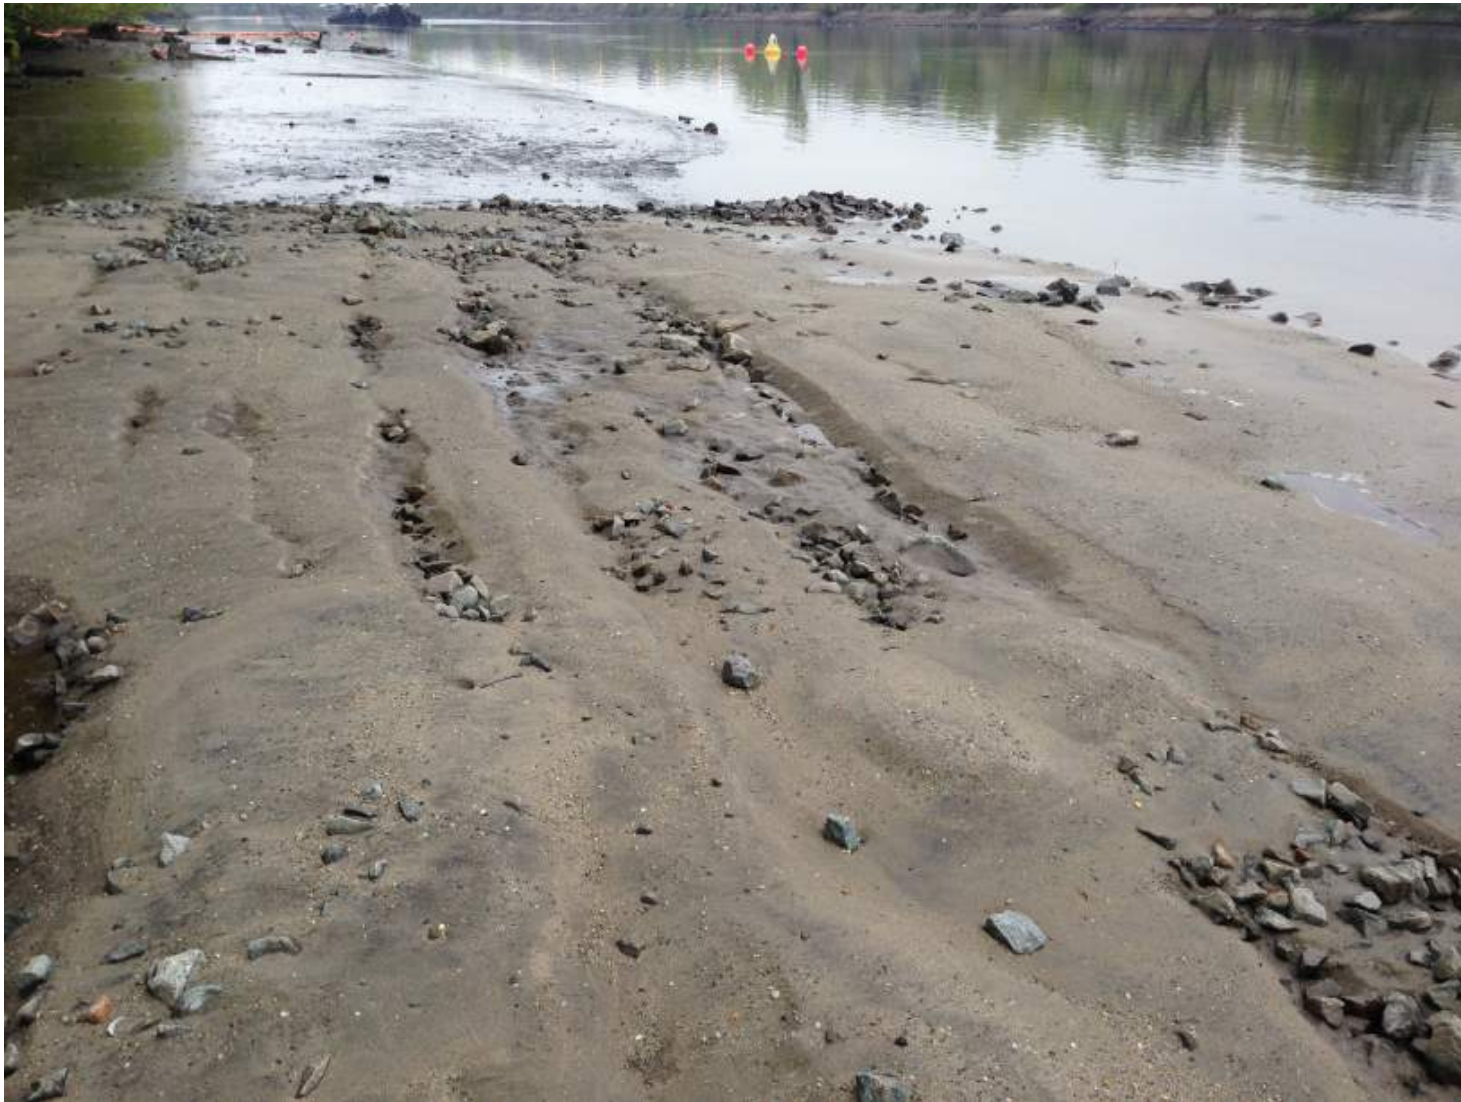
Habitat Layer after Two Lifts

The above photograph shows the test area where two layers of sand were applied, after approximately 24 hours had elapsed. There is a relatively even surface, and the exposed armor stone is limited. Two lifts of sand will be applied over the entire capping area.

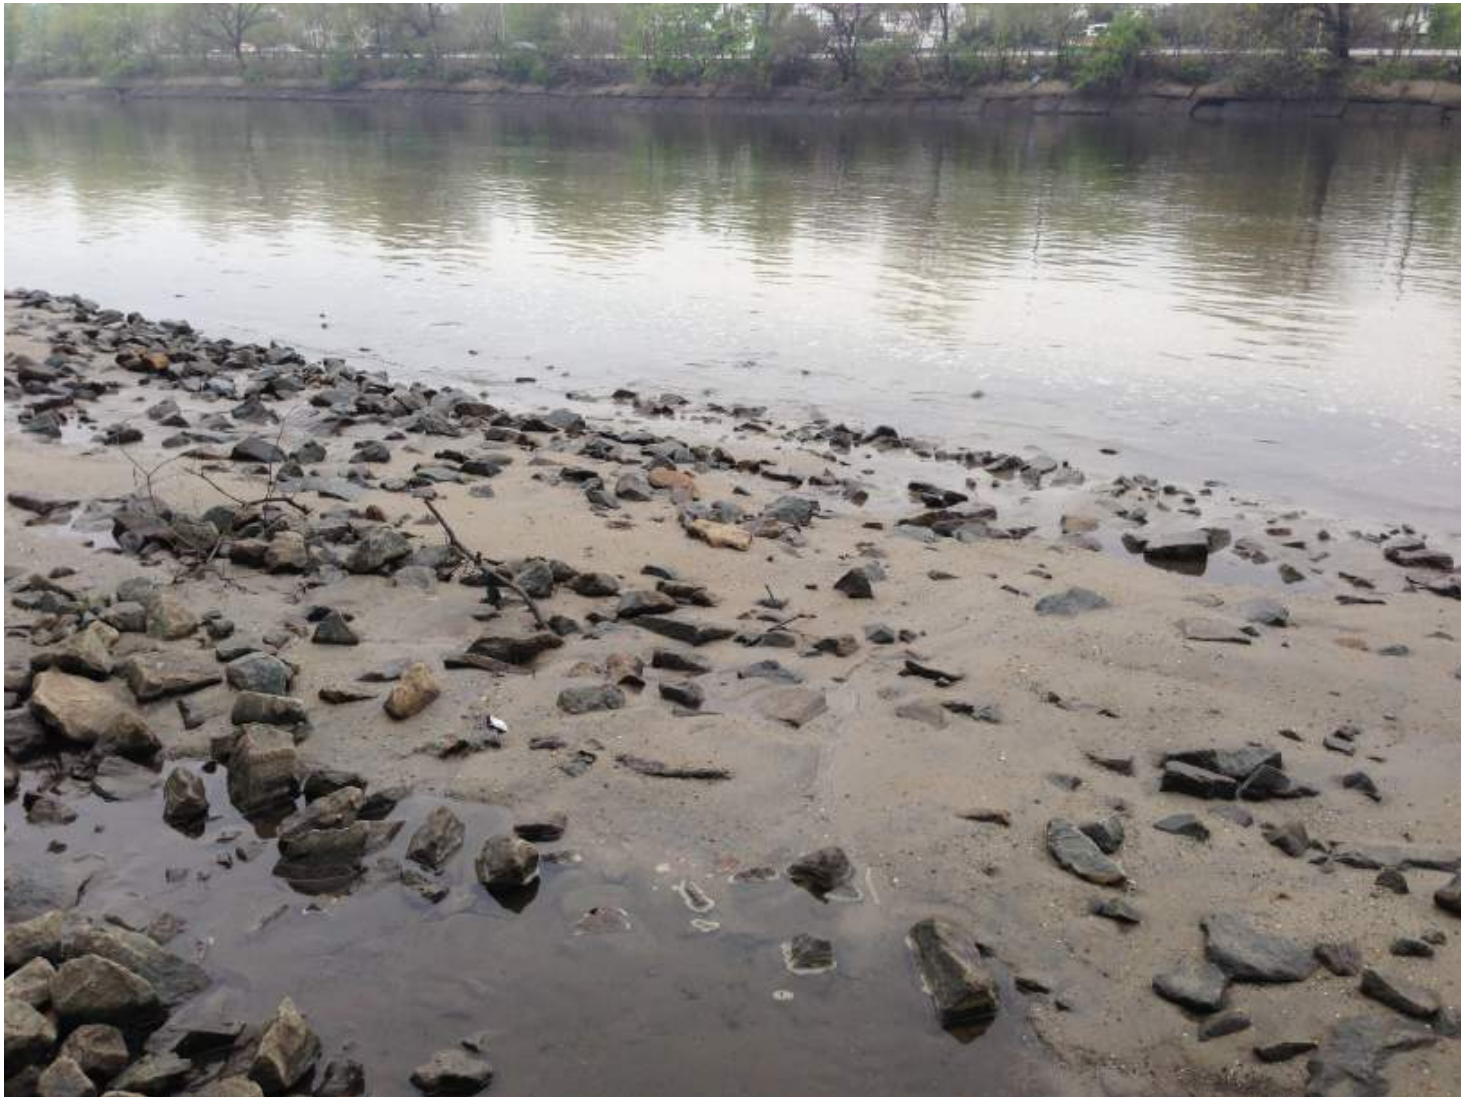
Habitat Layer after One Lift

In areas where only one layer of sand was applied, a significant amount of armor stone remained visible and there was not an even surface. It was determined that this would not provide a suitable habitat layer.

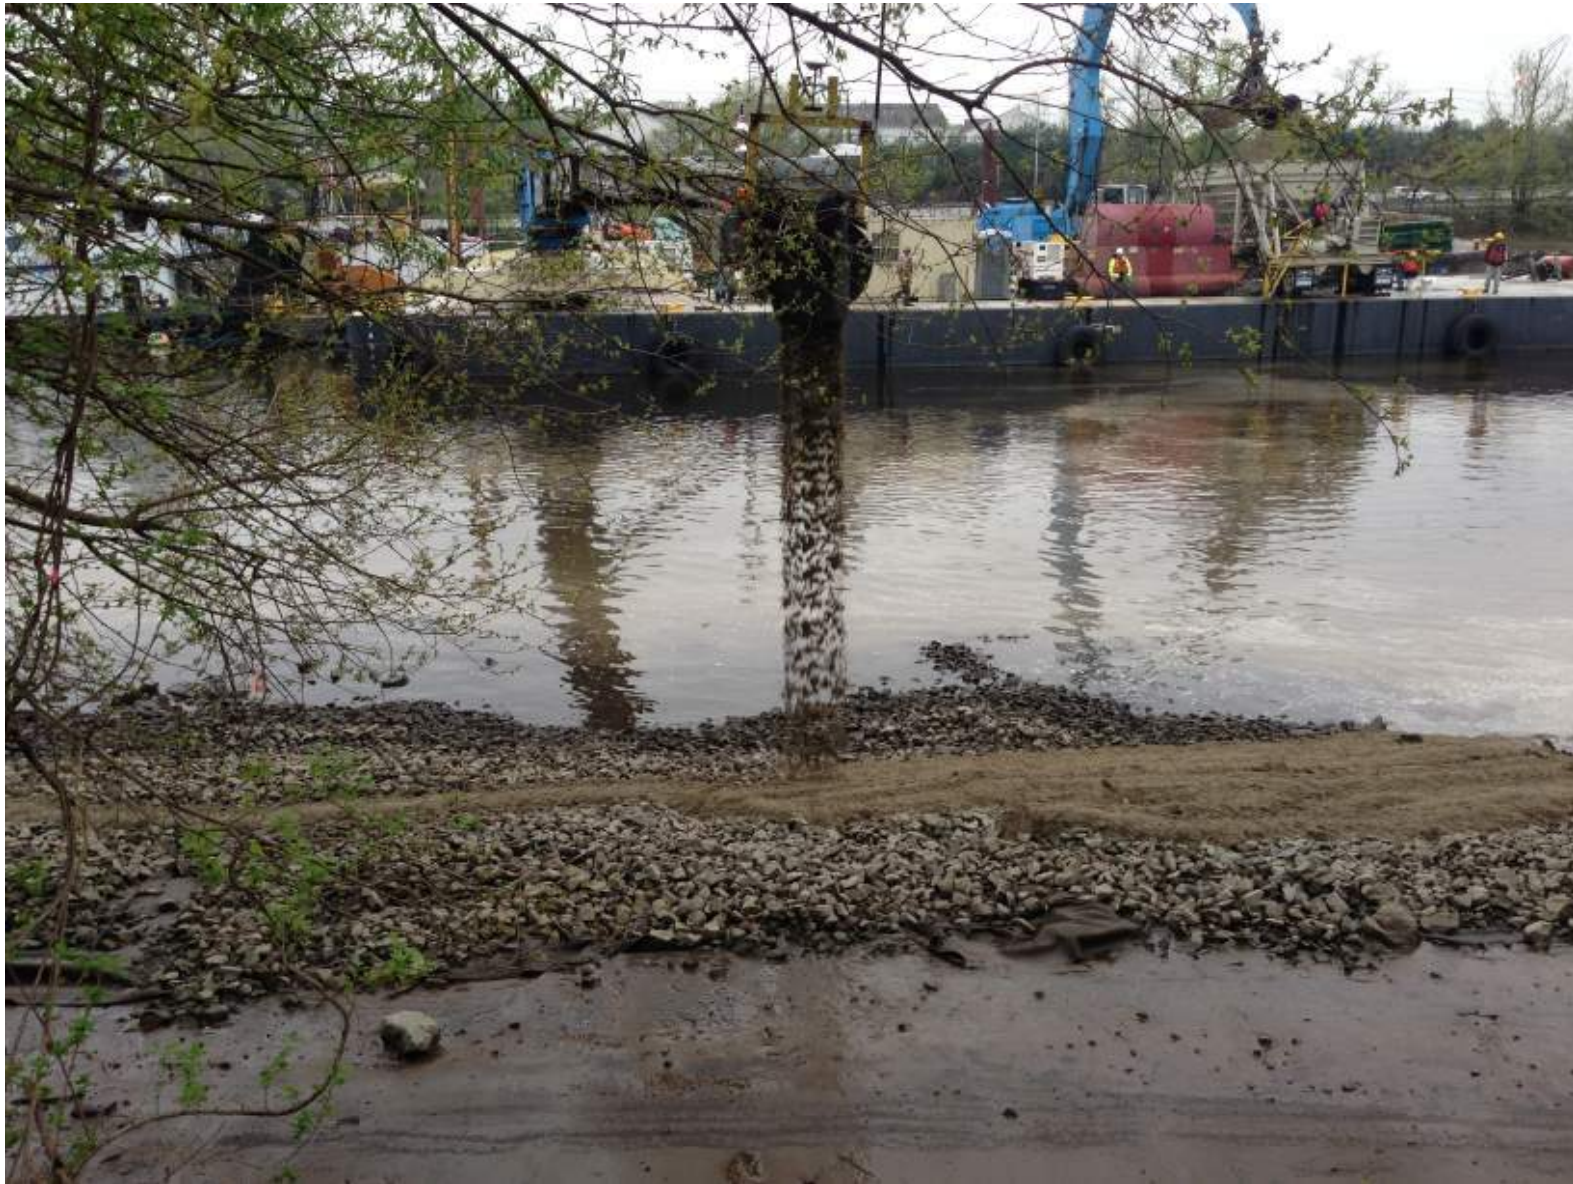
Habitat Layer Placement

GLDD applied sand throughout the day. Once the determination was made to provide two lifts of sand, it was implemented immediately; they covered today's work area twice.

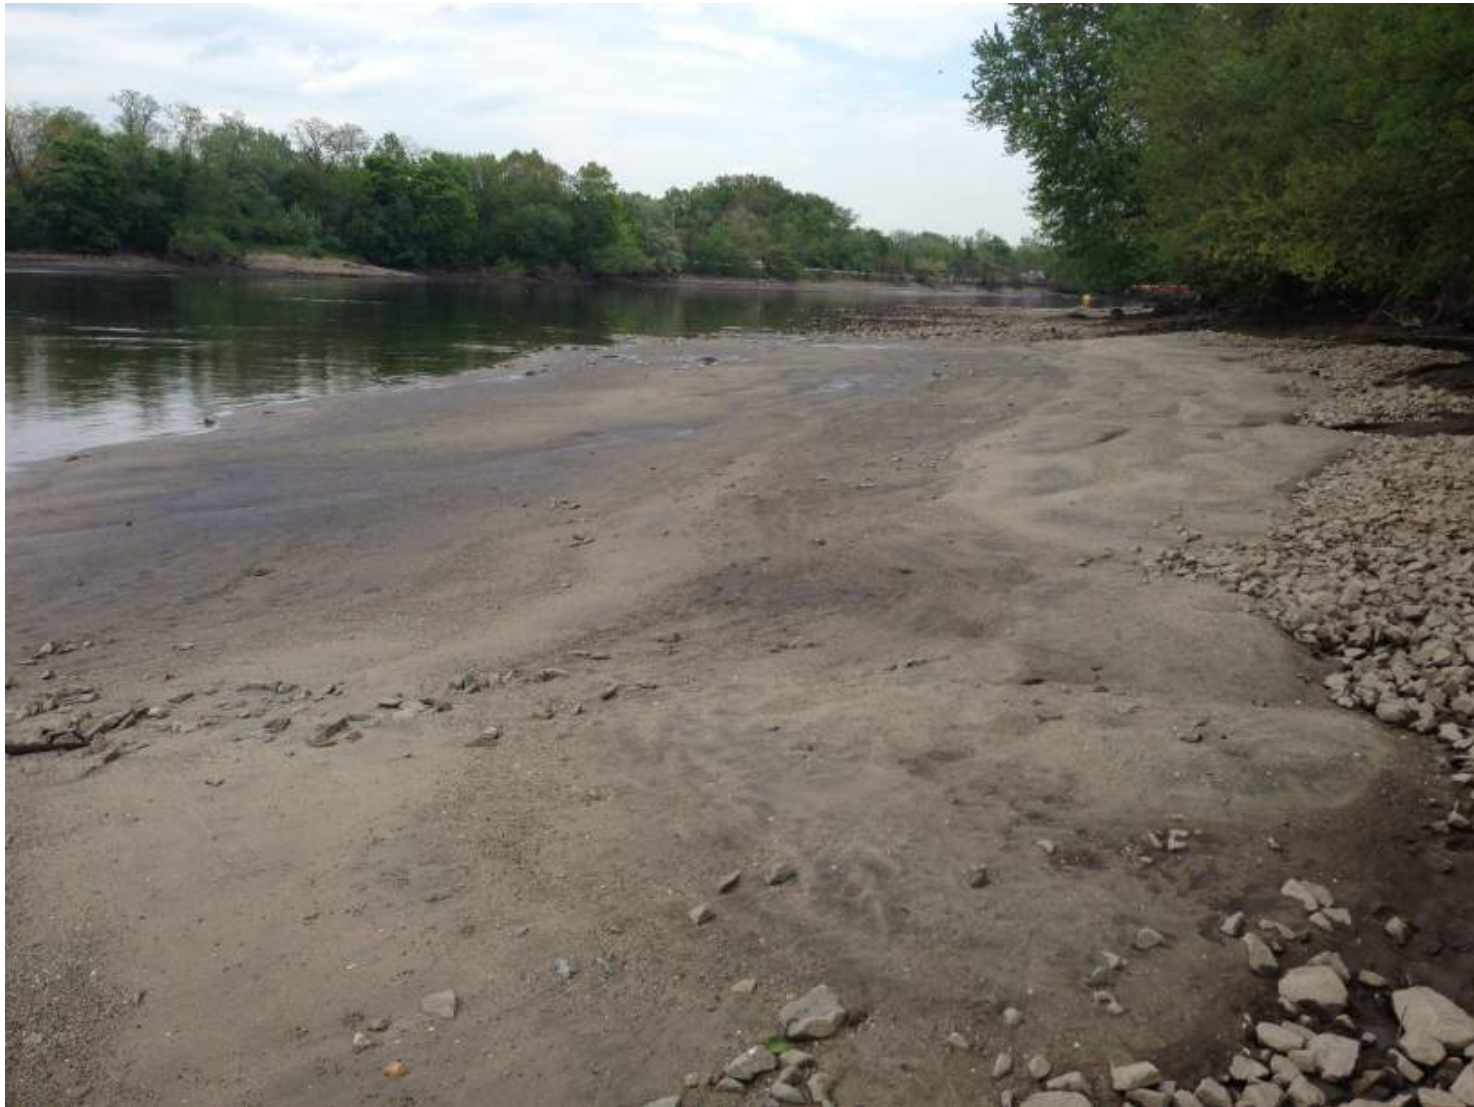
Habitat Layer Three Days After Placement

The above photograph shows where two lifts of sand were applied on Friday, May 9th. There is a relatively even surface, and the exposed armor stone is limited. Two lifts of sand will be applied over the entire capping area.

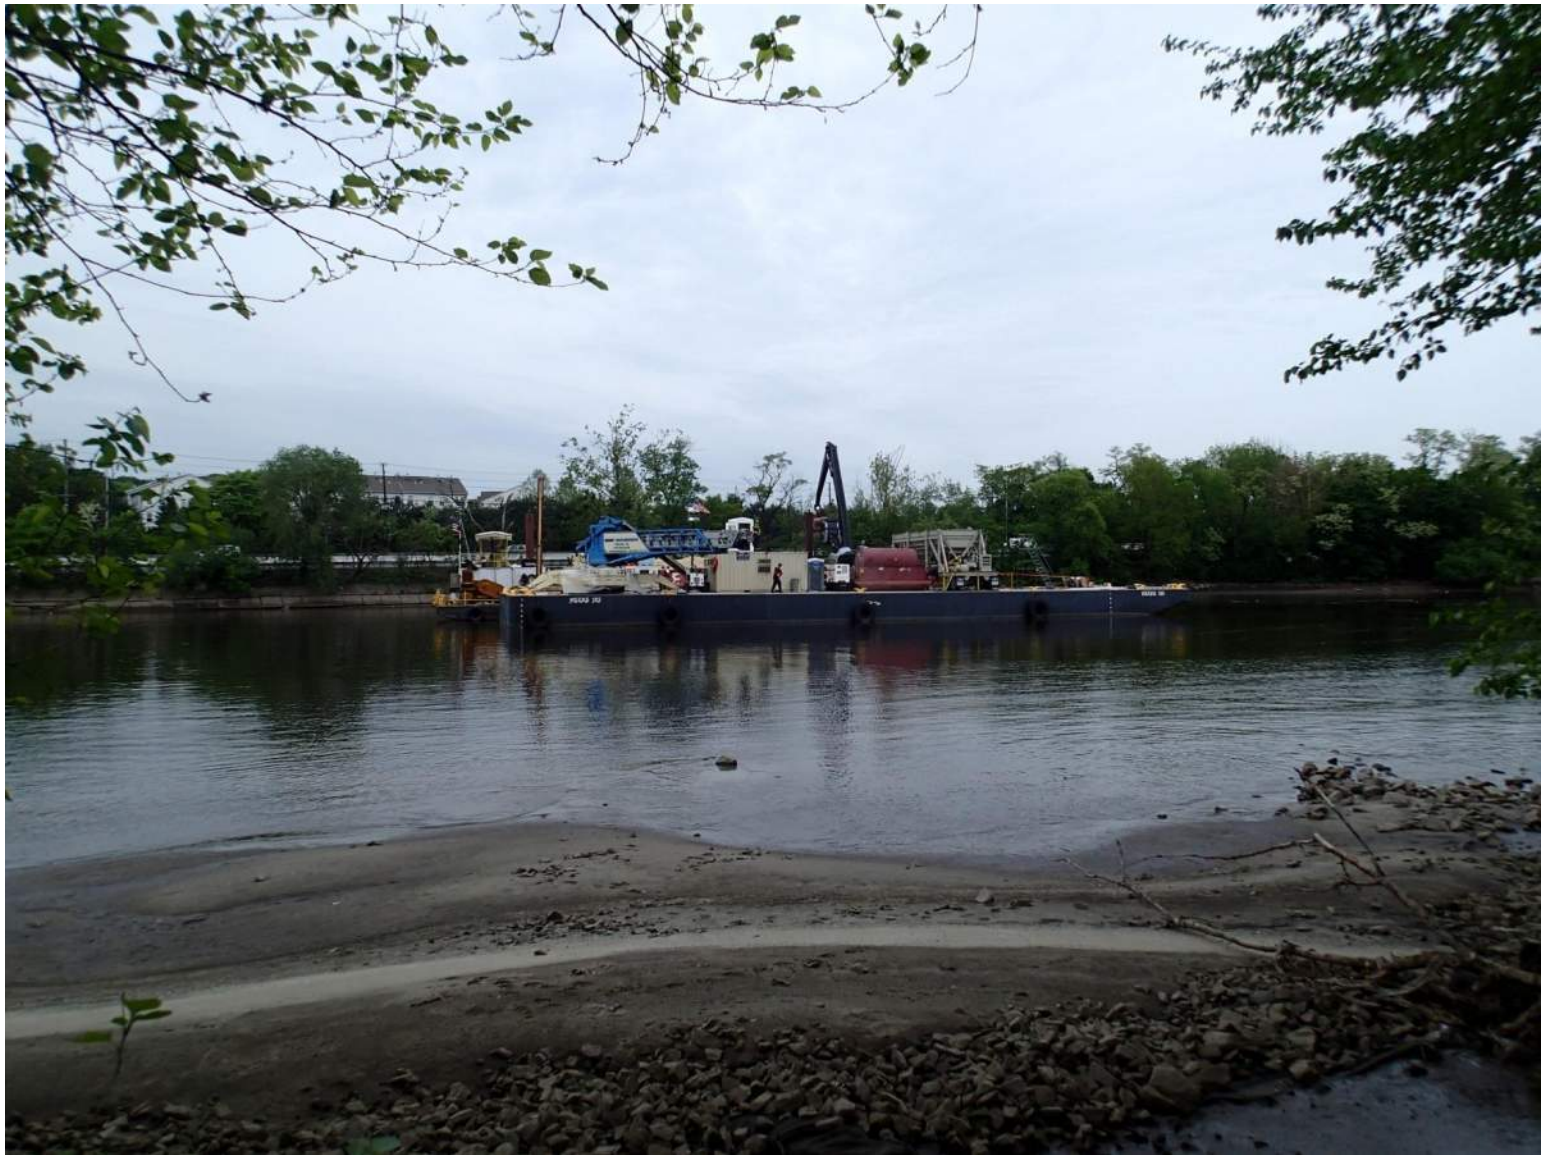
Onsite Set Up

11:13 – GLDD crew still preparing the new excavator and replacing a missing O-ring.

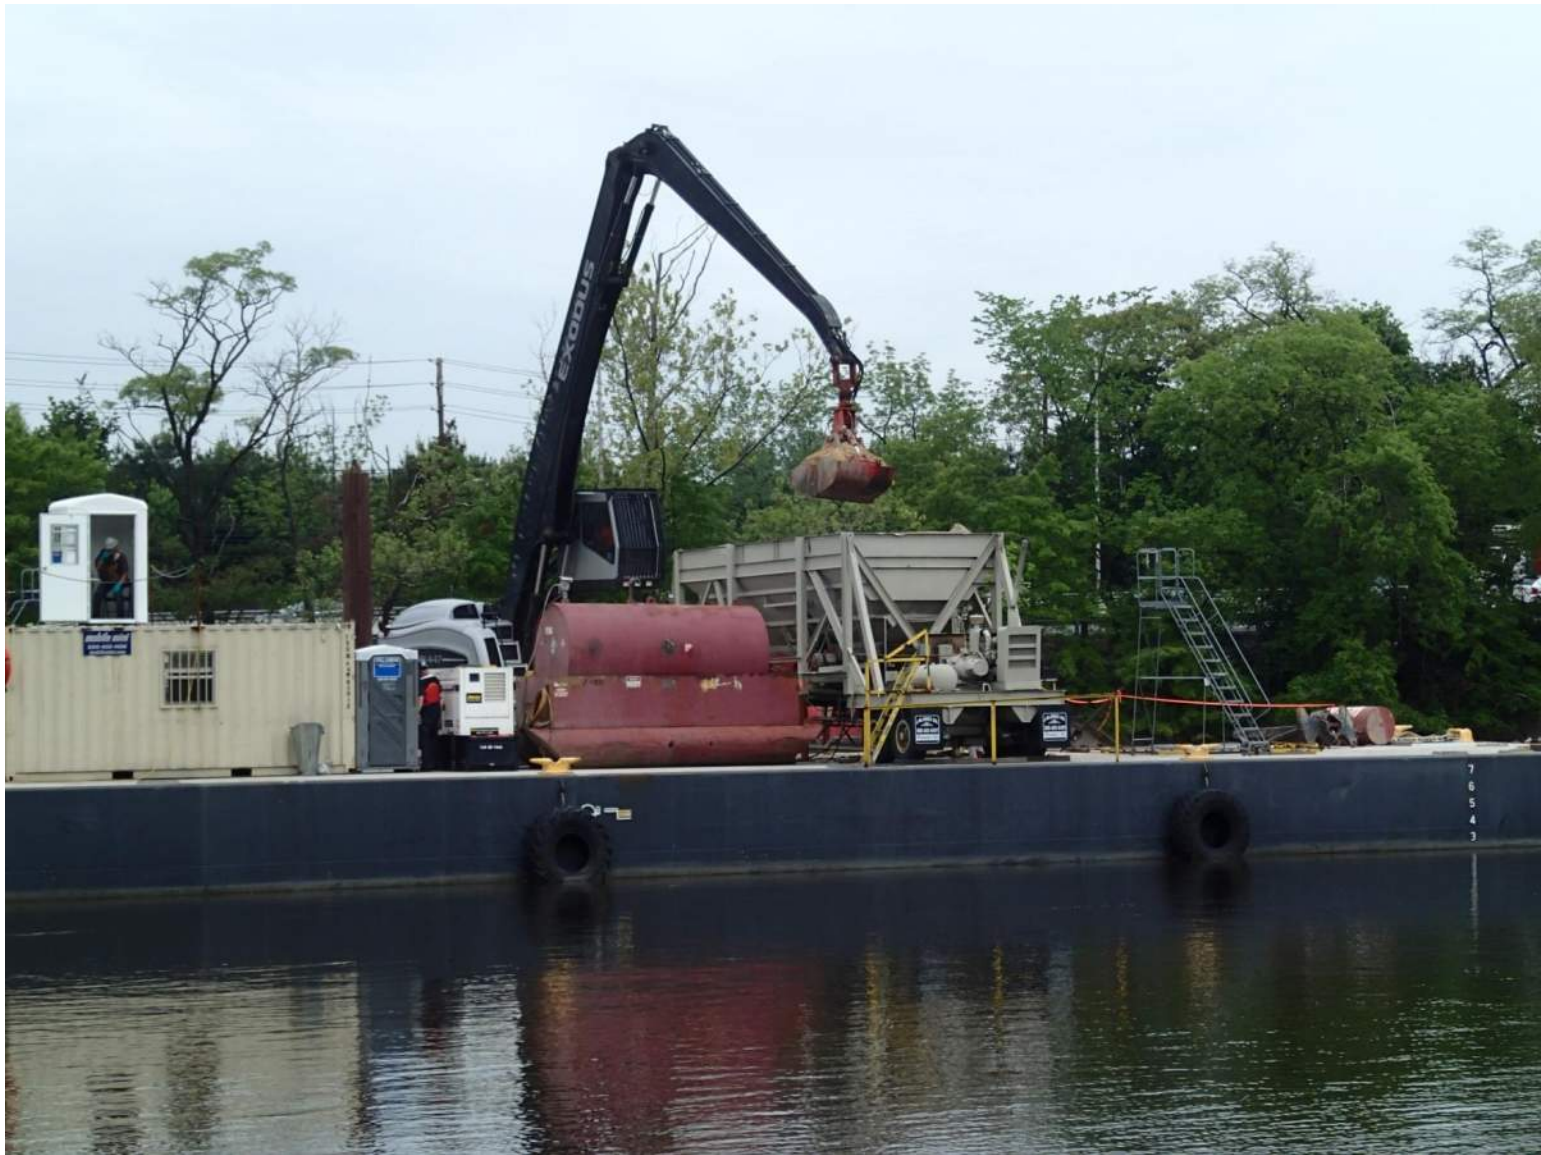
Unloading Sand

11:14 – GLDD unloading sand from the scow into the hopper.

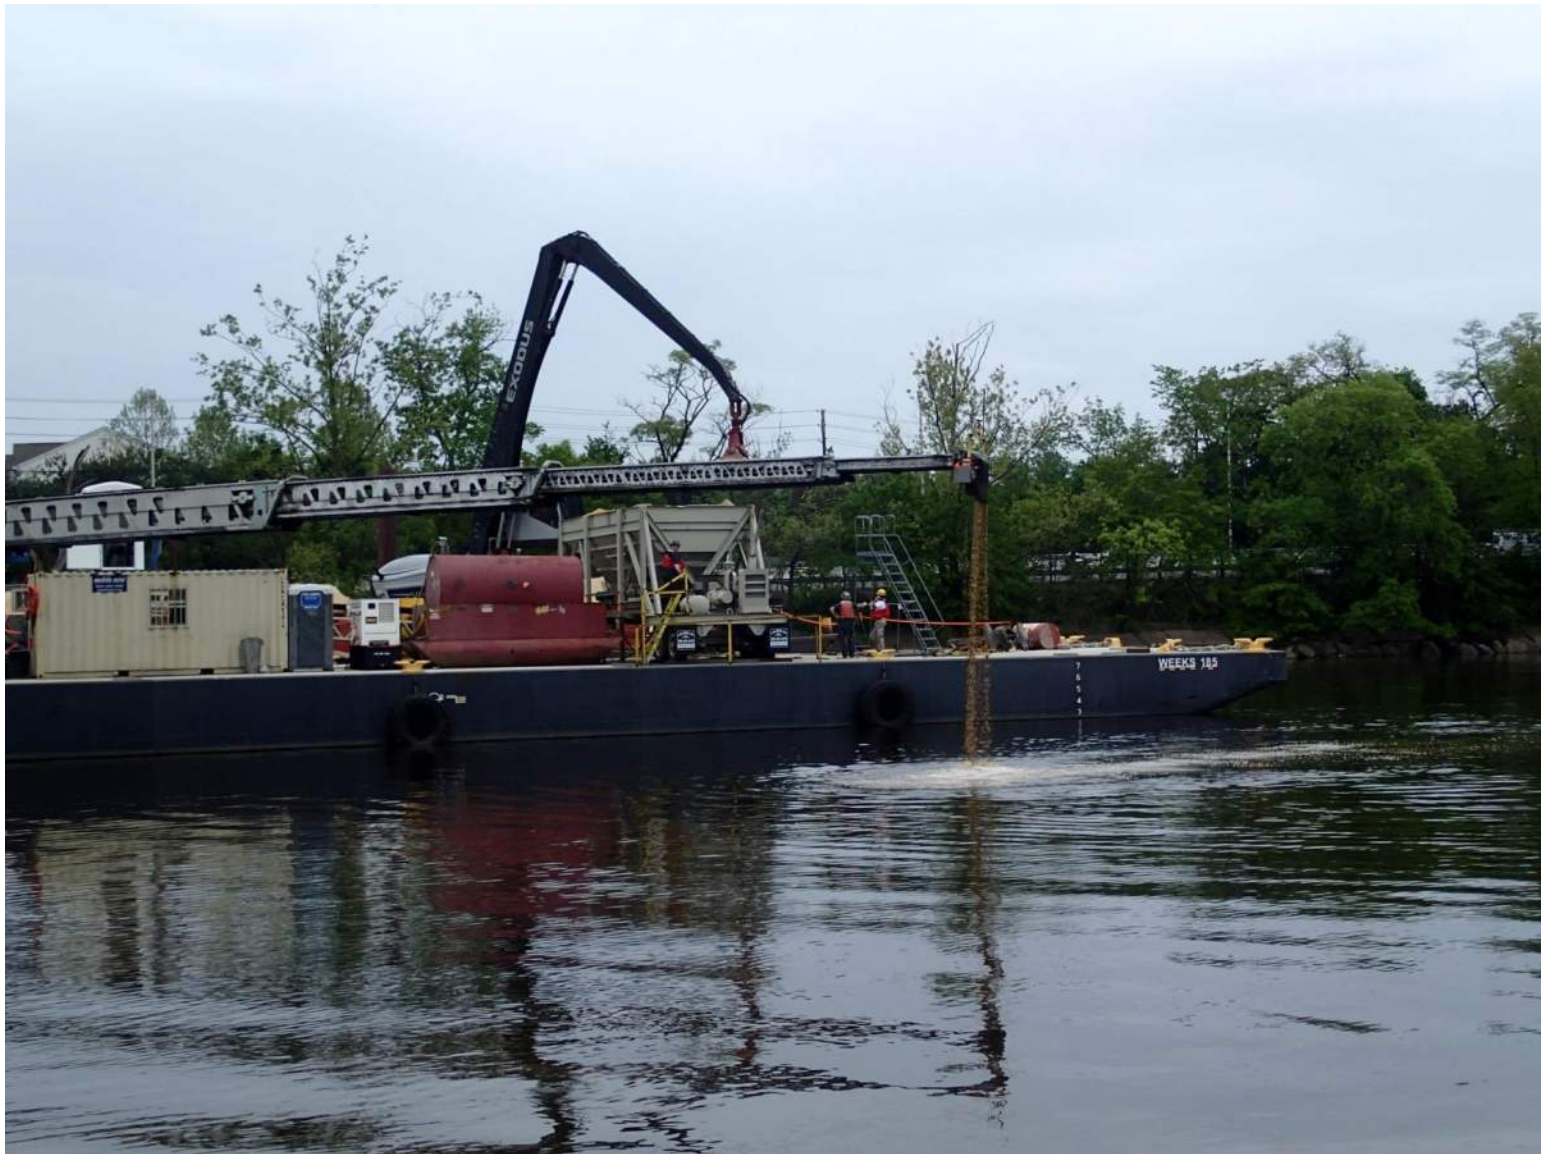
Habitat Layer Placement

11:40 – Placement of habitat layer sand resumes south of the No Dredge Zone. This is the second pass in this area.

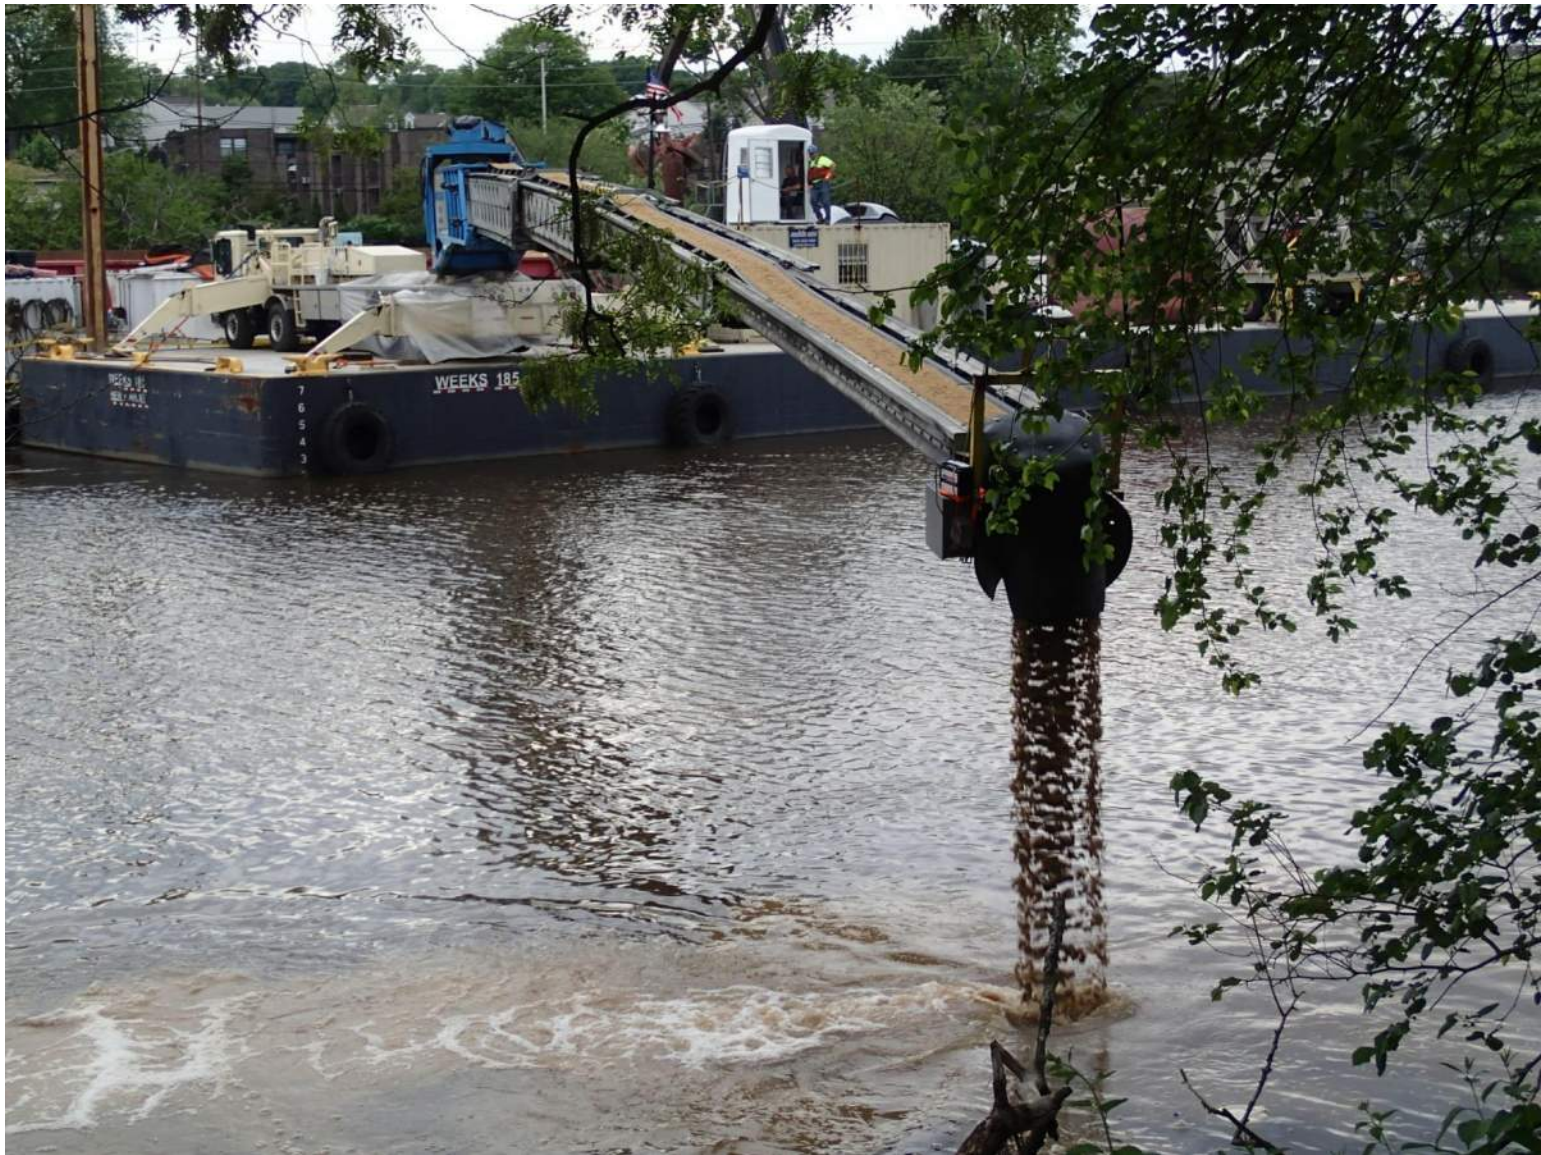
Habitat Layer Placement

17:31 – Placement of habitat layer sand continues south of the No Dredge Zone. This is the second pass in this area.

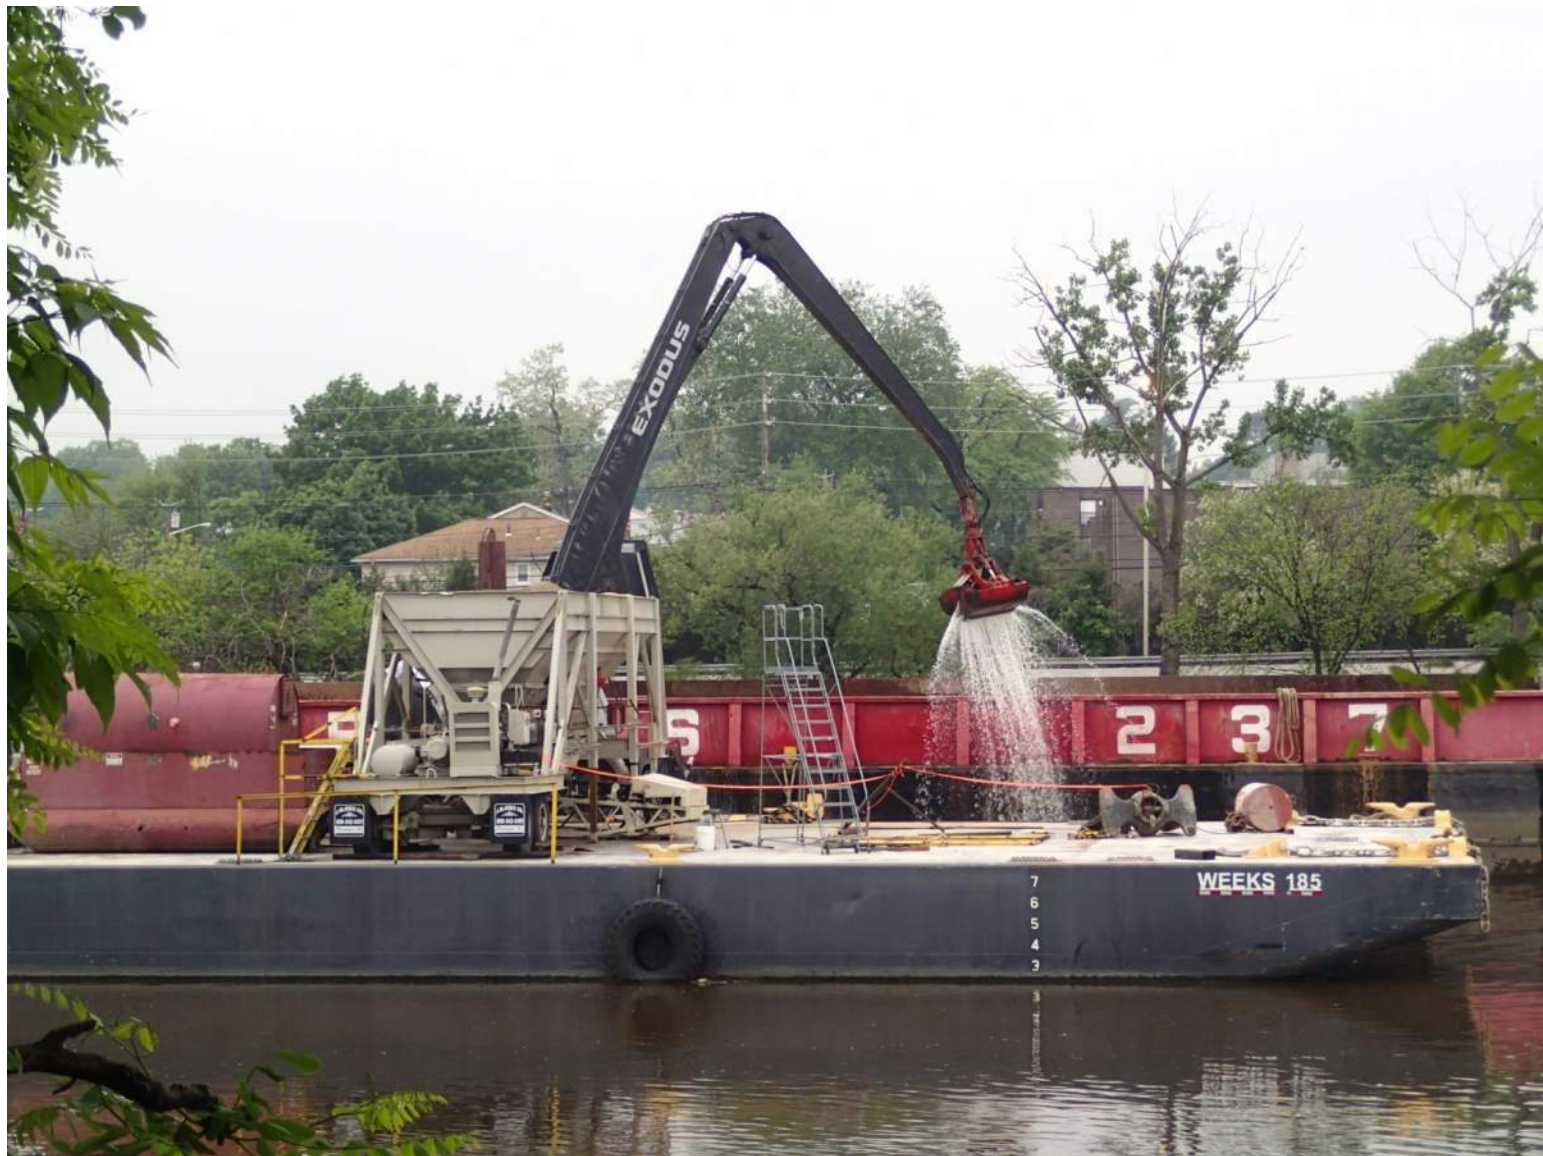
Cleaning Sand Scow

10:04 – Excavator bucket used to clean out the empty sand scow by placing water in it. Habitat layer placement was stopped during this time as the sand scows could not be moved at low tide.

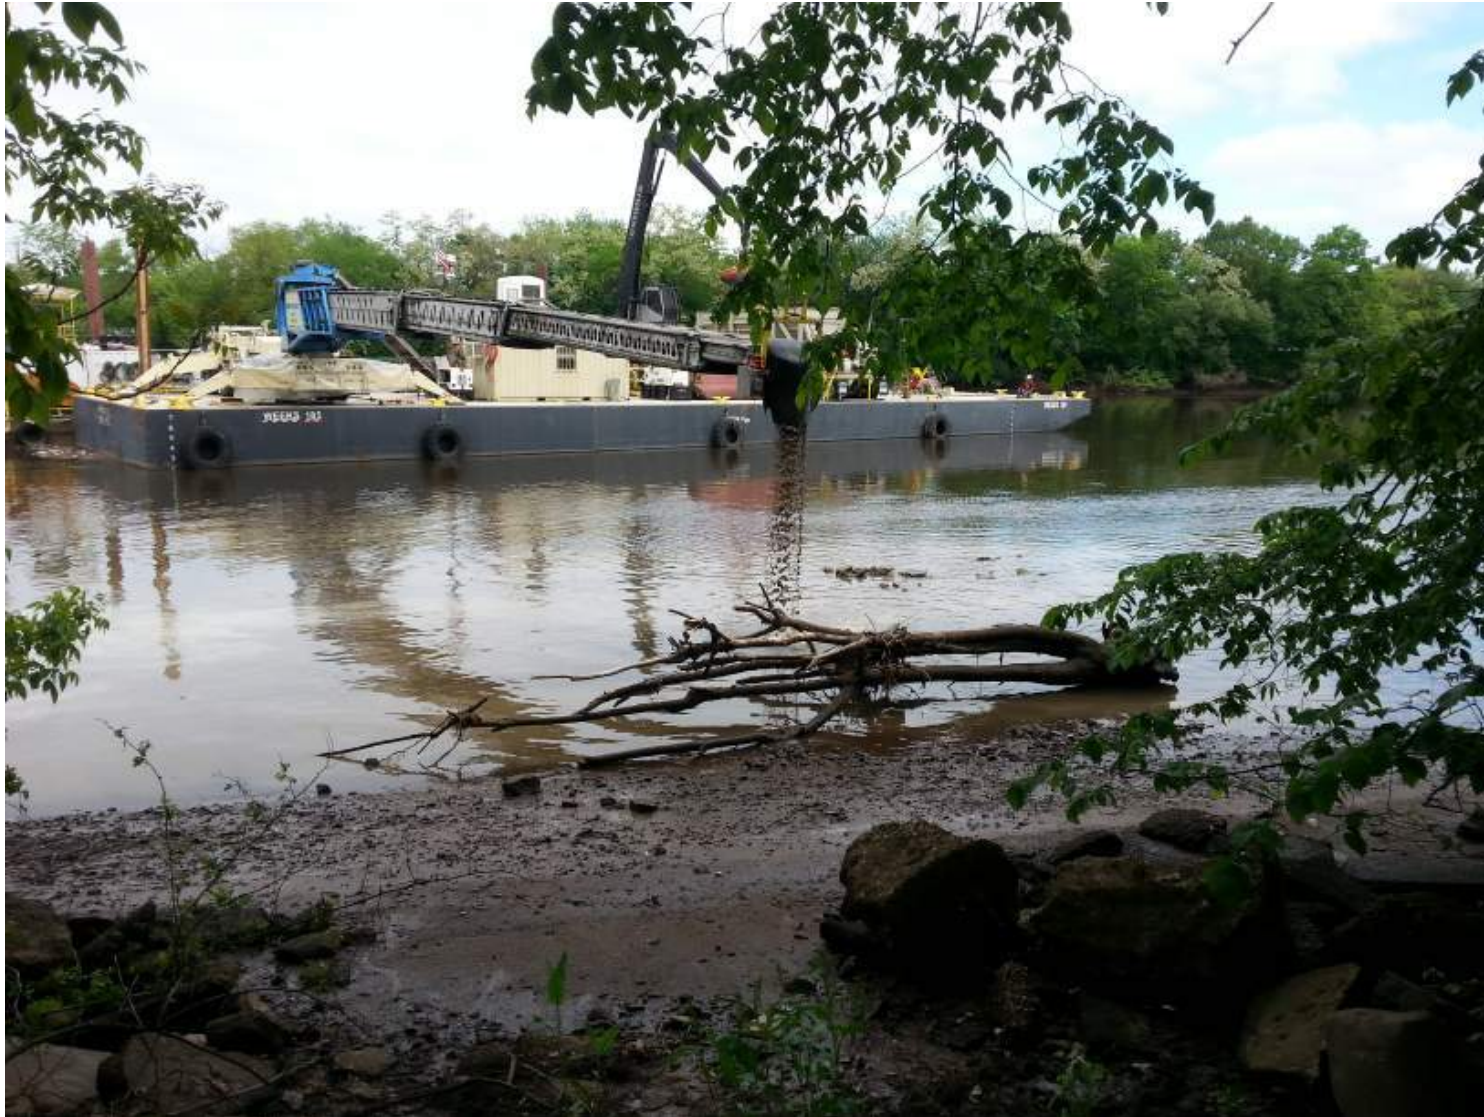
May 24, 2014 1018: GLDD performing habitat layer installation, immediately south of the No Dredge Zone.

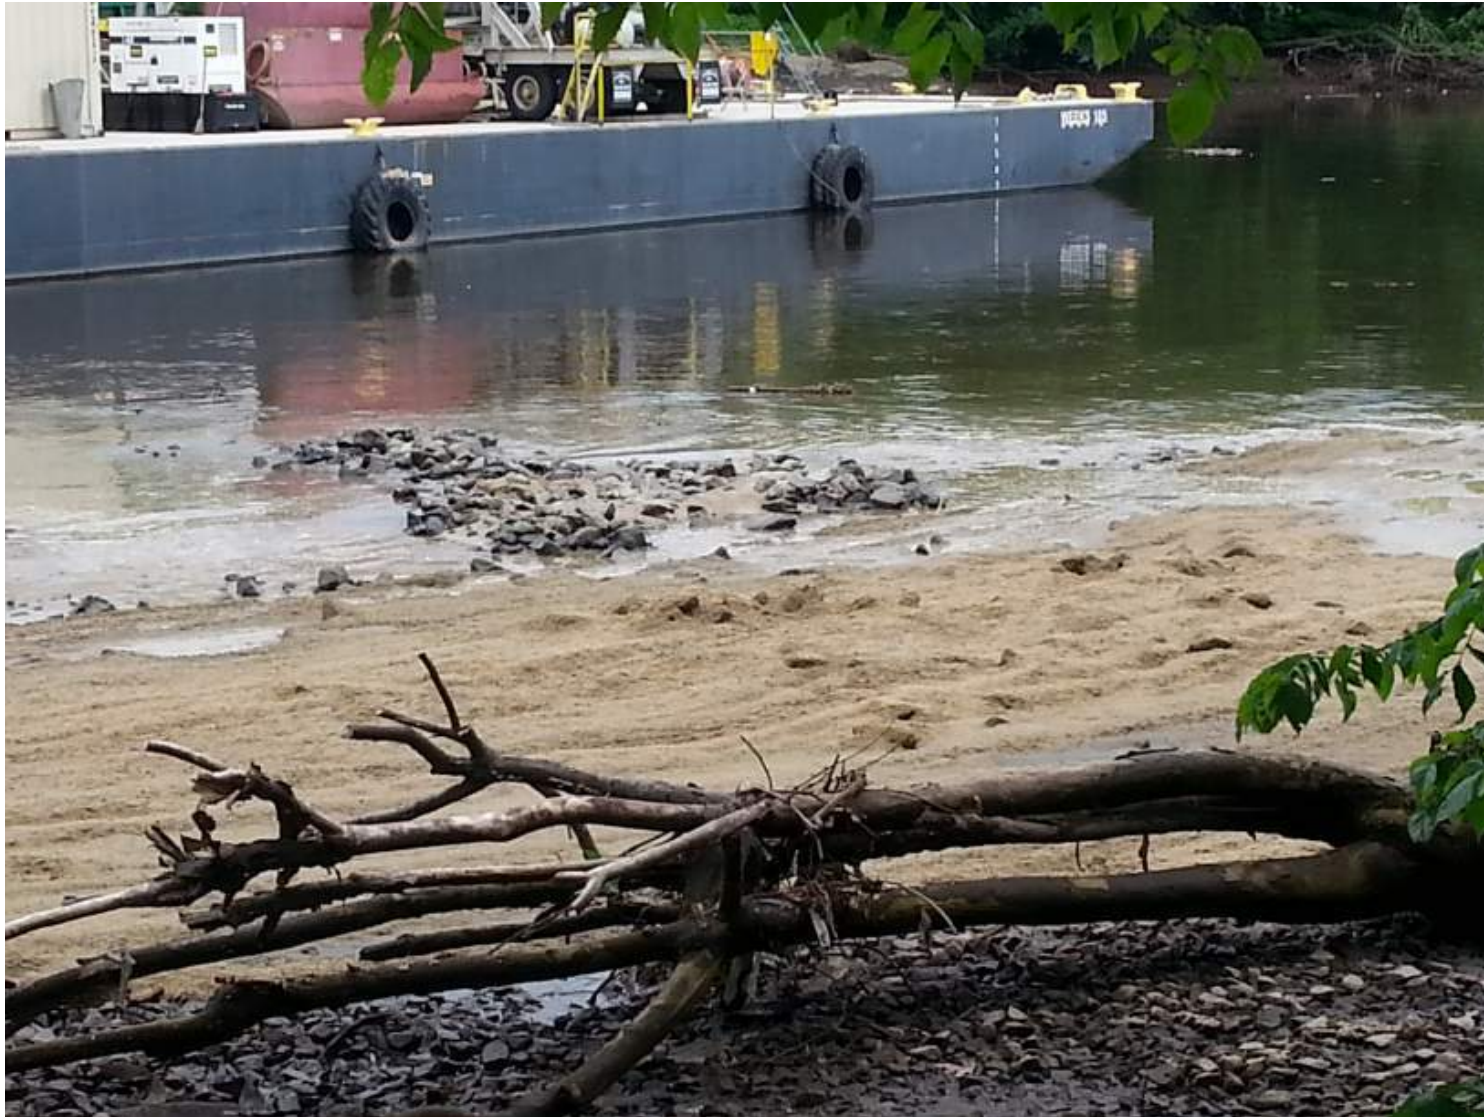
May 24, 2014 1136: Habitat layer placed during low tide, immediately south of the No Dredge Zone (armor stone high spot in the background).
